February 3rd, 2016

Re: Summary Report – Structural Assessment for Liberty Mill in Bellows Falls, VT
S&A Project #15-016

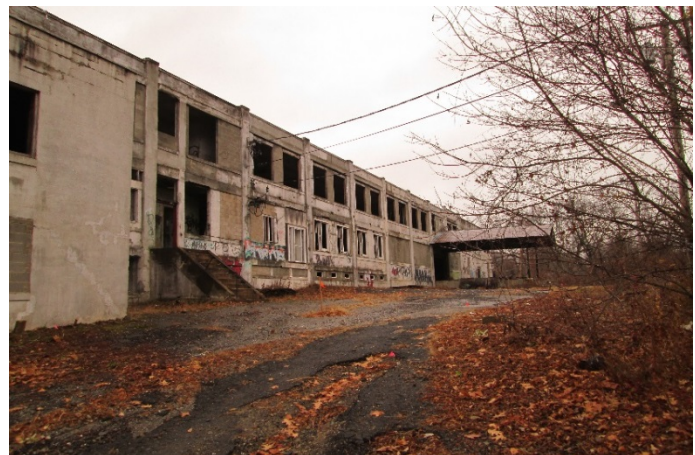
Photo 1 – Eastern Elevation of Liberty Mill
